# Safety Inspection Report

Annual Inspection

## Recreation Field

Box Parish Council

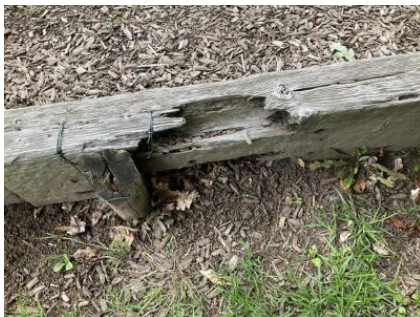
Timber is decayed.

Replace affected parts.

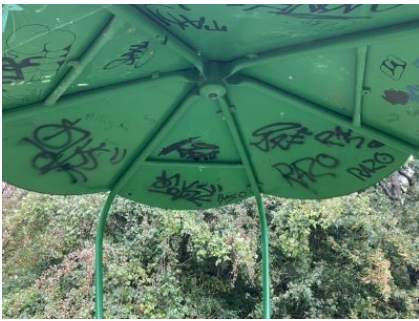
Fixtures loose or missing.

Tighten/replace.

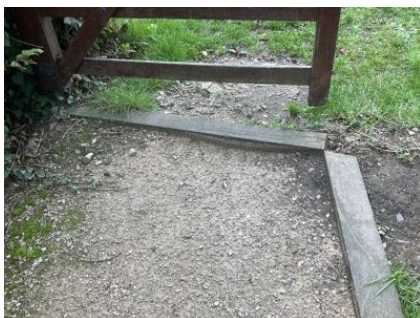
Description	Tasks	Risk score
Trip points on the surface.	Make level.

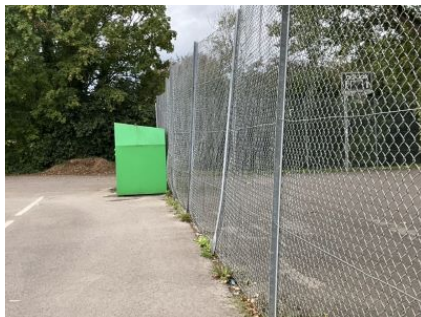
Description	Tasks	Risk score
Item is bent.	Read the notes for further action.

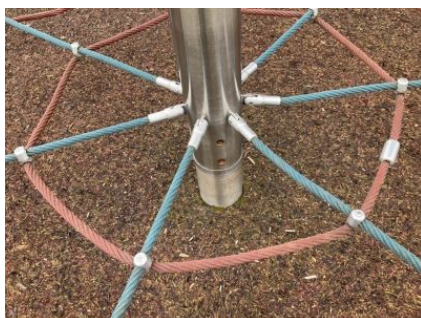
Fixtures loose or missing.

Tighten/replace.

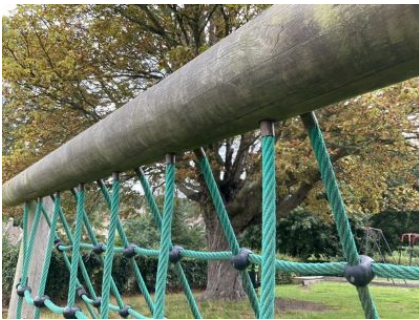
Check end of rope connections for corrosion.

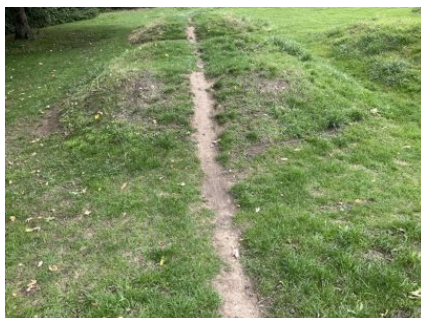
Description	Tasks	Risk score
Ground erosion present.	Repair the worn areas.

Repair the worn areas.

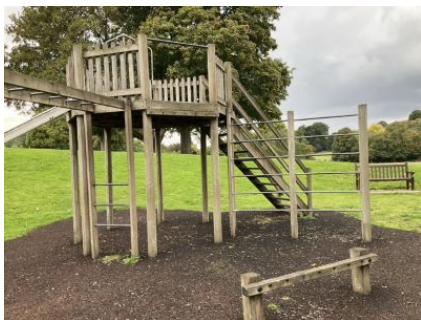
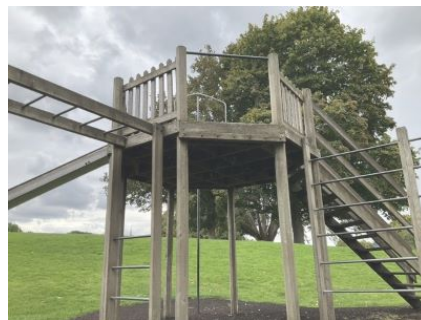
Item has some parts missing.

The net has been removed. There is no means of safe descent. Close platform opening or replace net.

Replace the missing parts., Read the notes for further action.

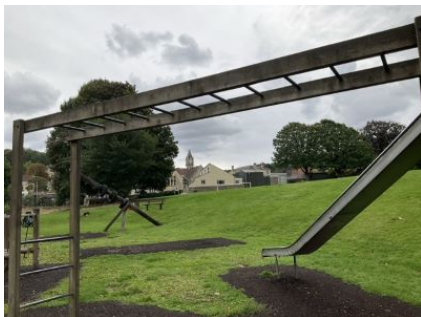
Overhead ladders and rings provide significant play value and benefits to children, and with it the risk of falling. Ensuring the surface remains in good condition will help to keep the correct balance between benefits and risk.

The protective surface under all bars and rings must be kept in good condition.

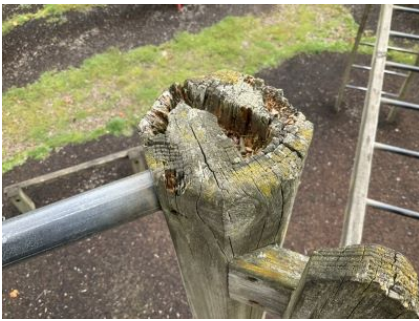
Timber is decayed.

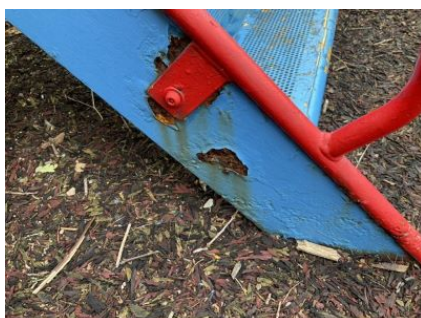
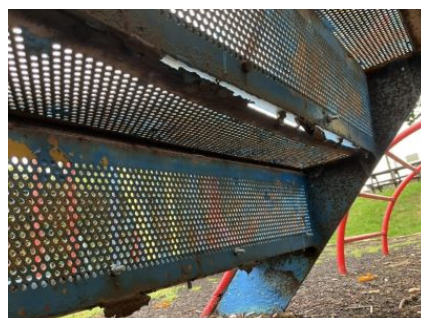
Item has corrosion.

The blue steps are very corroded with sharp edges underneath. Movement in the steps. Corrosion in the frame. The repair does not support the step.

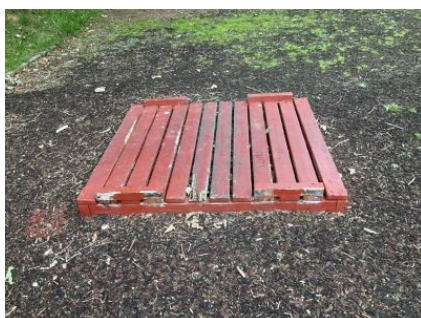
Description	Tasks	Risk score
Item is at the end of its useful working life.	Programme early replacement.

Programme early replacement.

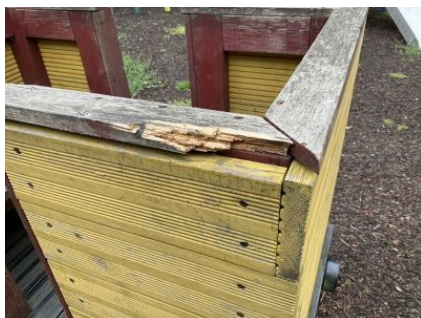
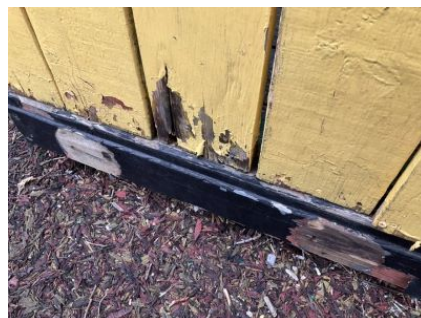
Timber is decayed.

Replace affected parts.

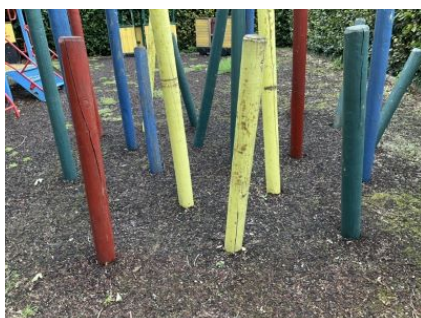
Loose in ground.

Some poles are loose but at the time of the inspection could no longer be pulled out of their holes. Monitor.

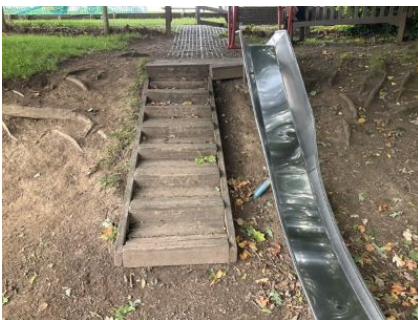
Timber is decayed.

Replace affected parts.

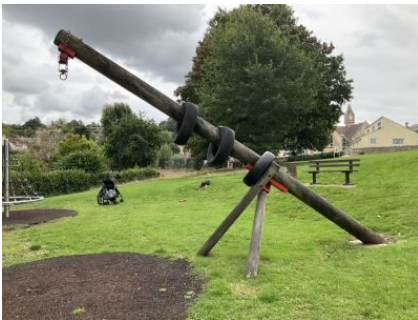
This equipment relies on one post for its stability. Special attention should be paid to maintenance (e.g. by monitoring degradation) and if necessary decommissioning the item before the end of its operating life. This is a requirement of the British Standard.

Resistance penetration testing can be undertaken to confirm the structural integrity of the timber.

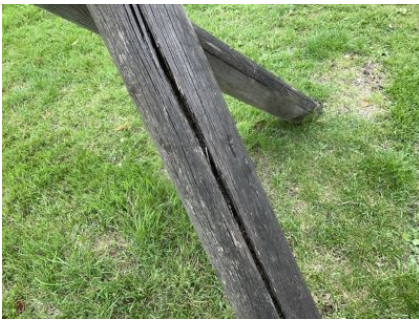
Timber is decayed.

Soft spots in air cracks.

We recommend resistograph testing to determine the internal condition of the timber. We can undertake this testing at additional cost. Please contact us for details.

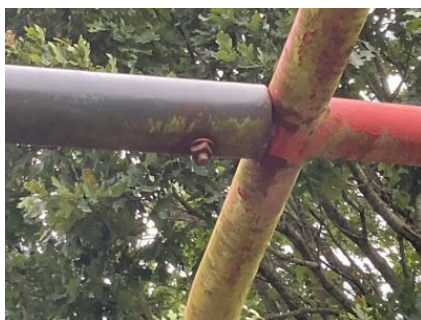
Fixtures loose or missing.

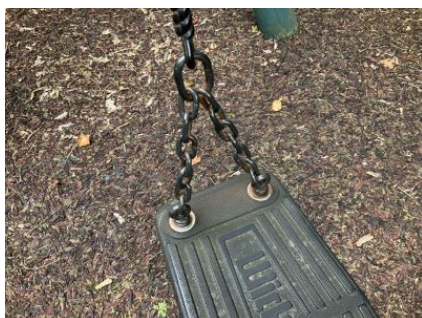
Some chain wear.

Monitor for further deterioration and replace before 40% wear.

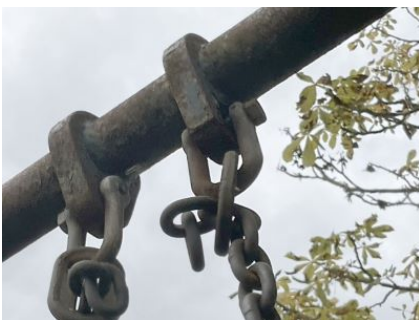
There is wear in the bushes.

Remove shackle bolt and check bush and shackle pin wear, replacing as necessary.

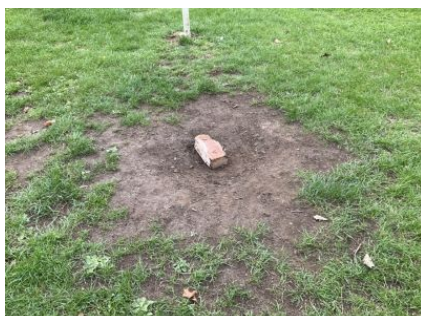
Description	Tasks	Risk score
Ground erosion present.	Repair the worn areas.

Repair the worn areas.
