# Safety Inspection Report

Annual Inspection

## Recreation Field

Box Parish Council

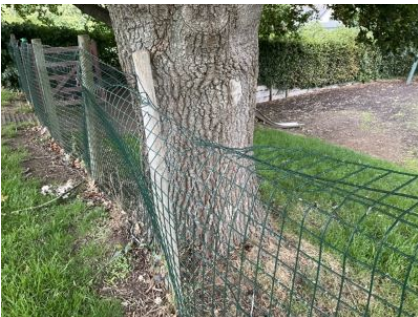
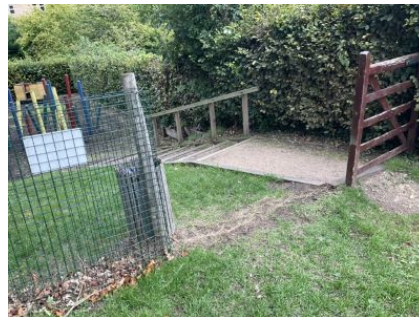
# Fencing

Minor repairs are needed.

Repair.

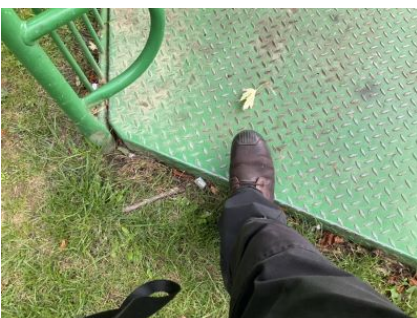
# Shelter

Fixtures loose or missing.

Tighten/replace.

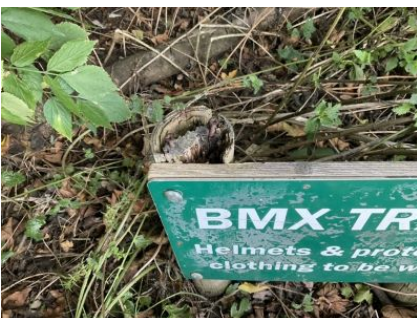
# Signage - BMX

Timber is decayed.

Replace affected parts.

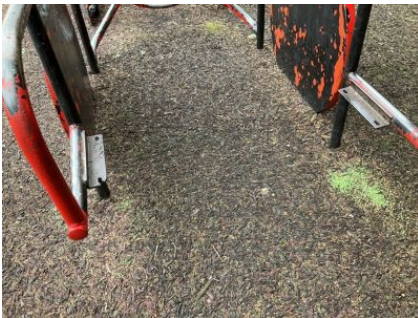
Item has some parts missing.

Replace the missing parts.

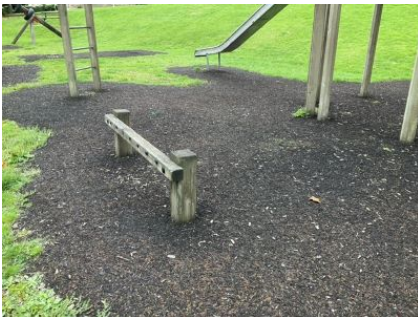
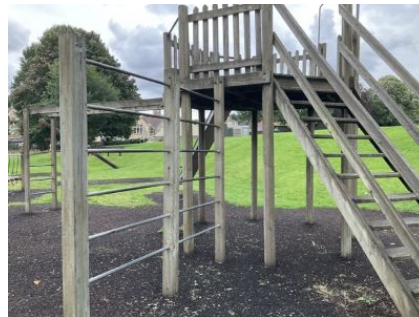
# Multiplay

1. There is an obstacle in the falling space or minimum space.
2. Access fails the entrapment requirements.

1. Item has some parts missing.
2. Overhead ladders and rings provide significant play value and benefits to children, and with it the risk of falling. Ensuring the surface remains in good condition will help to keep the correct balance between benefits and risk.
3. Timber is decayed.

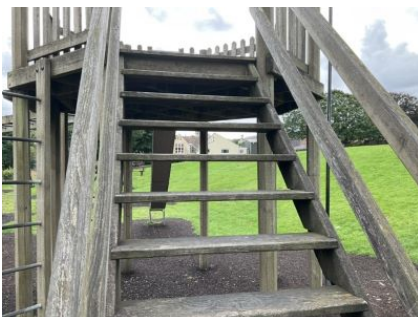
Access fails the entrapment requirements.

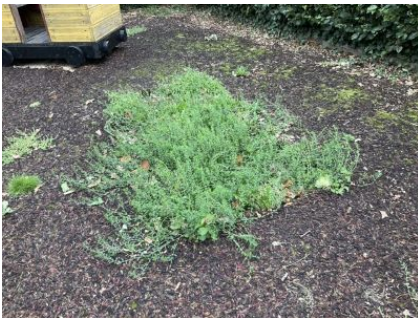
# Play Train - Wooden

Item has some parts missing.

Replace the missing parts.

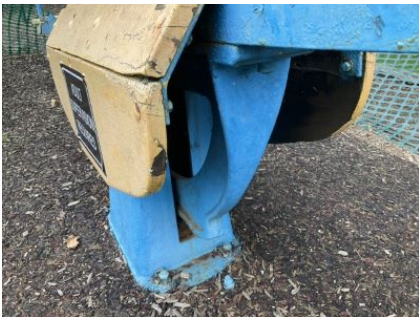
There are crushing points in the open mechanism. Replace the item.

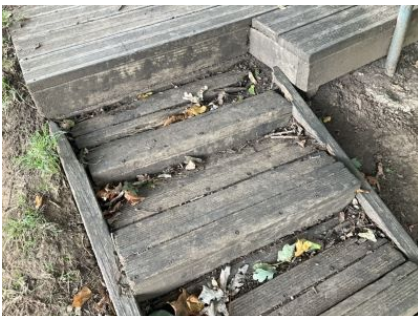
Timber is decayed.

Replace affected parts.

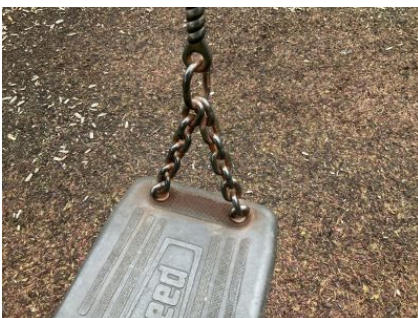
Some chain wear.

Monitor for further deterioration and replace before 40% wear.

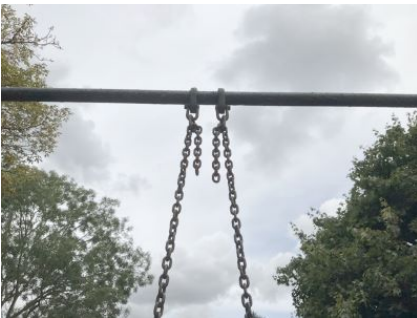
Chain has snagging hazard caused by surplus links.

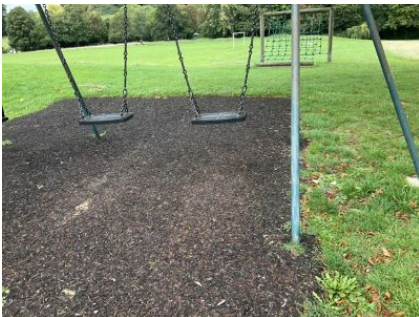
There is wear in the bushes.

Remove shackle bolt and check bush and shackle pin wear, replacing as necessary.

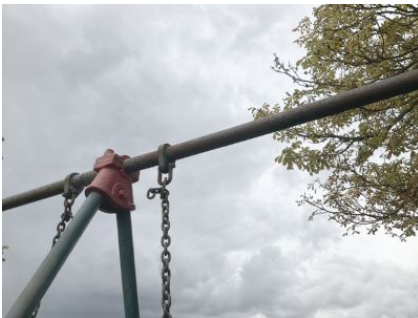
Item has corrosion.

Treat and repair.

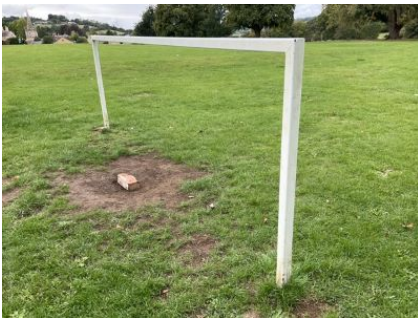
Loose in ground.
